MISCELLANEOUS PAPER SL-80-19

CONCRETE DETERIORATION  
IN SPILLWAY WARM-WATER CHUTE  
RAYSTOWN DAM, PENNSYLVANIA

December 1980

Final Report

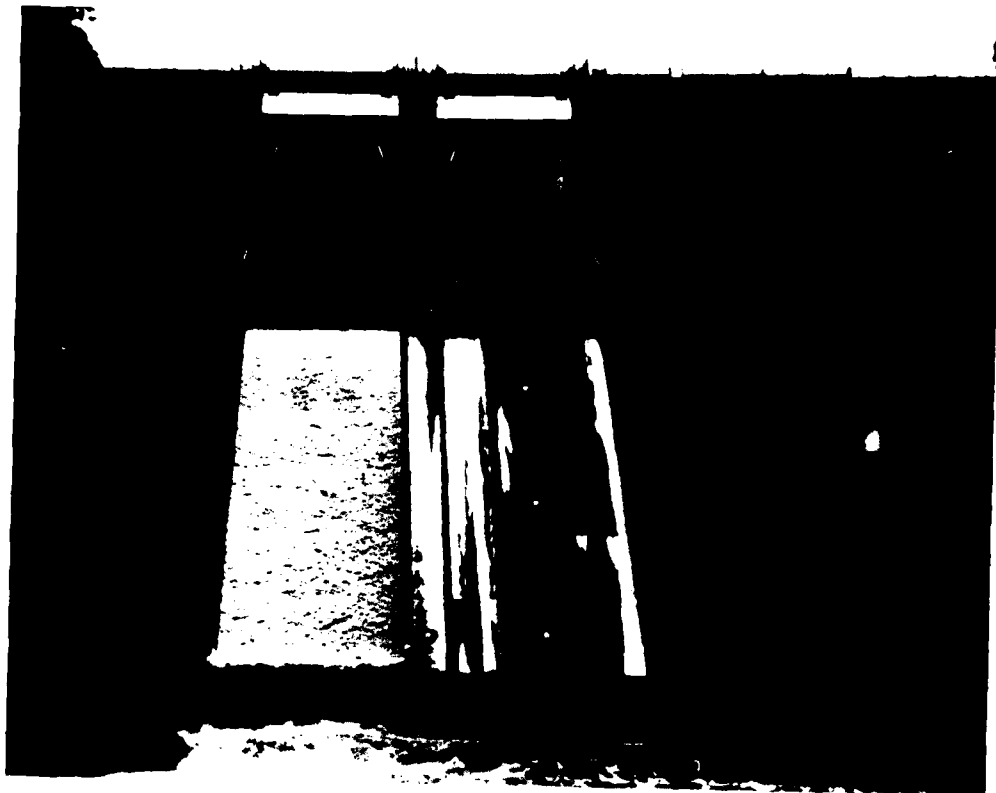
Figure 2. Control structure, Raystown Dam. The warm-water chute is the narrow chute in the center of the spillway

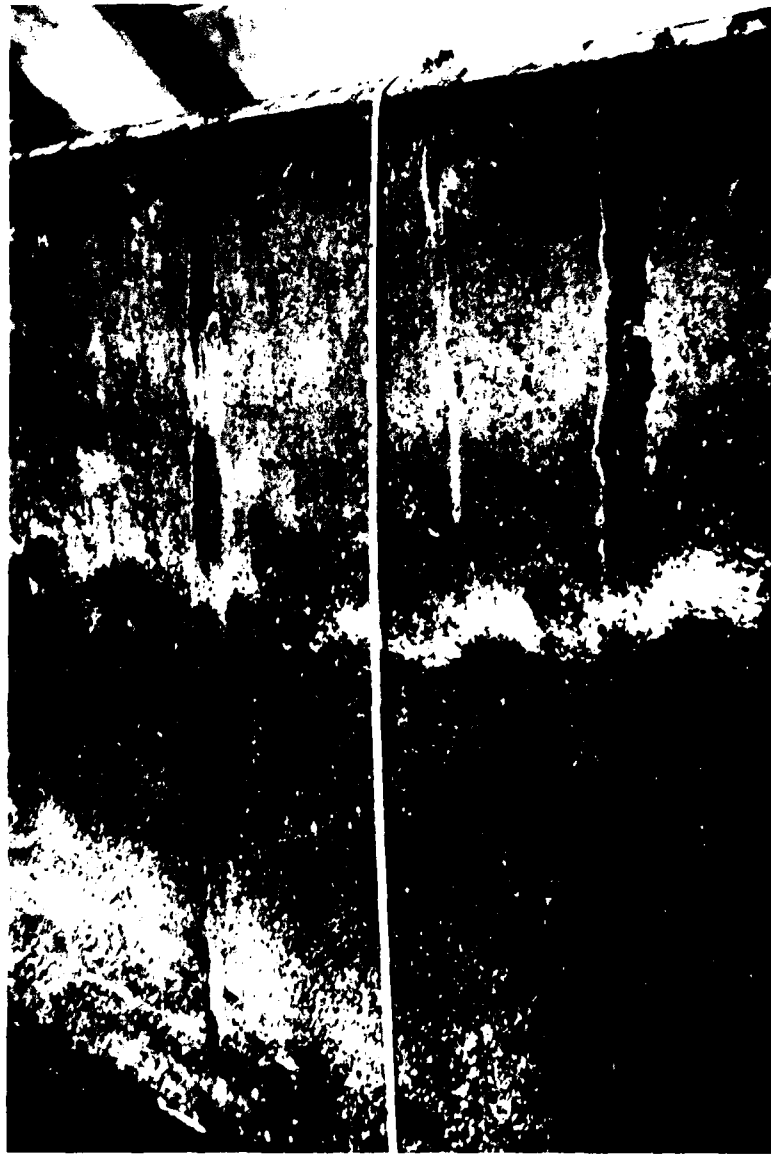
- a. Damage near the mouth of the warm-water tunnel (i.e., upstream end of the chute) is noticeable for the full height of the wall. As one moves downstream, the damaged zone tends to reduce in height, but the severity of the damage increases in the lower portion of the wall. Typically, upstream, the lower portion of the wall (below the indicated waterline as shown by discoloration and algae) shows missing aggregate particles and numerous voids. The surface of the concrete is extremely sandy with little or no paste visible. Above the waterline, voids and bug holes (many are apparently a result of construction since the holes have a small exterior opening and a larger interior volume) are visible to the top of the wall. Figure 5 shows a wall section near the mouth of the tunnel. Figures 6 and 7 show close-up views of the damage in the upper and lower portions of the wall.

Figure 5. Full height section of wall of warm-water chute.  
Note differences in damage above and below the apparent  
waterline

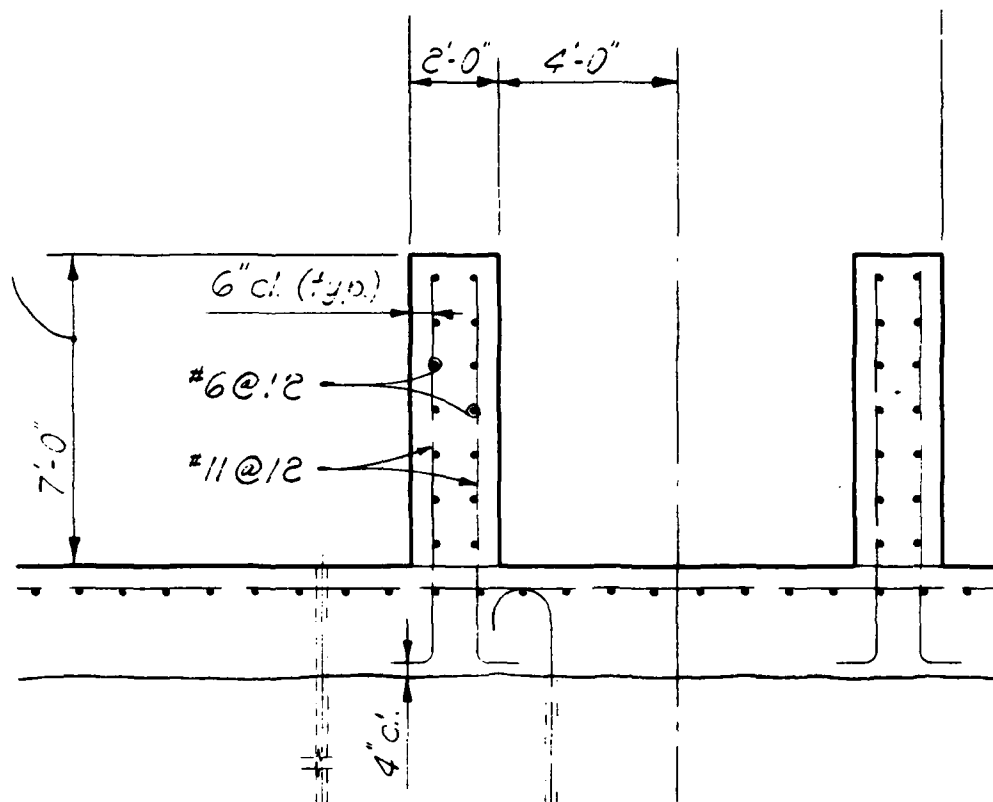
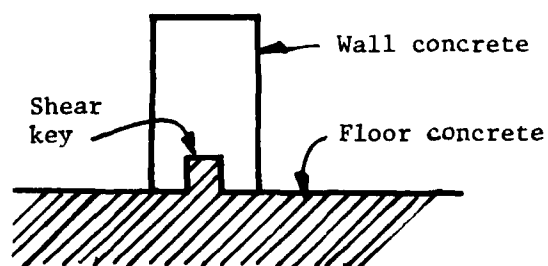
Figure 15. Warm-water chute wall construction technique

surface which is apparently a shear key. Figure 15 compares the contract drawings and the actual construction. The construction technique as shown has allowed water to flow under and inside the walls of the warm-water chute.

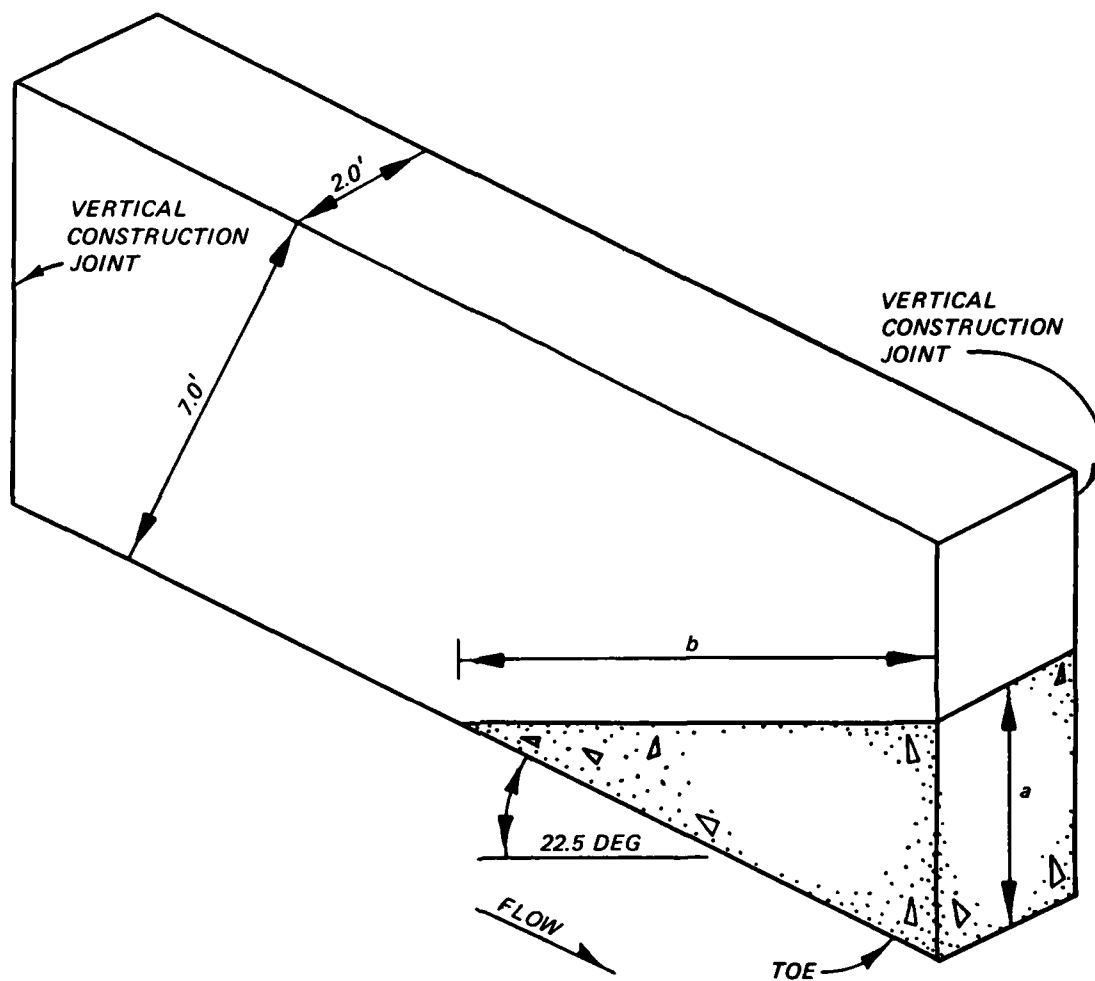
14. The consolidation of the concrete in the walls must be considered. The most severe damage to the interior of the walls is located at the downstream toe of several wall segments. Due to the geometry of the placements, a small volume of concrete would have filled the forms very rapidly during the initial stages of the placement for each wall segment (Figure 16). The depth of the concrete would have increased quickly, making consolidation in the toe area difficult. With the exceptions of the water shown flowing through a void in the concrete in Figure 11 and the cold joint shown in Figure 12, exterior evidence of poor consolidation has been obliterated by the surface damage now present or by the mortar coating which was applied during construction. However, based upon the rapid increase in concrete depth, the possibility certainly exists that less than complete consolidation was achieved in the toe area of some of the wall segments.

Figure 16. Schematic of wall section, warm-water chute.  
Note that concrete depth at toe builds up rapidly, making  
consolidation difficult

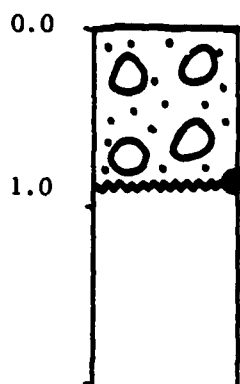
Top surface essentially as formed with etching of limestone coarse aggregate particles up to 1/16 in. deep. New break at 0.95 ft. End of core.

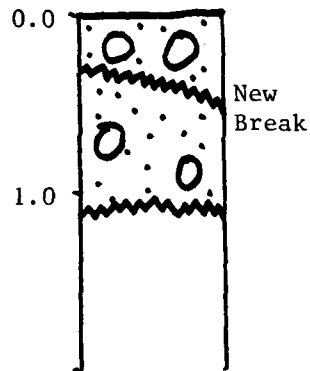
PLATE B5

The outer end is the roughened original surface with the limestone coarse aggregate particles etched to a depth of about 1/16 in.
